STRATEGOS TECHNOLOGY TRANSFERENCE

Expeditionary Lift Balloon MK II

ExLB.2 Instruction Manual & User Guide

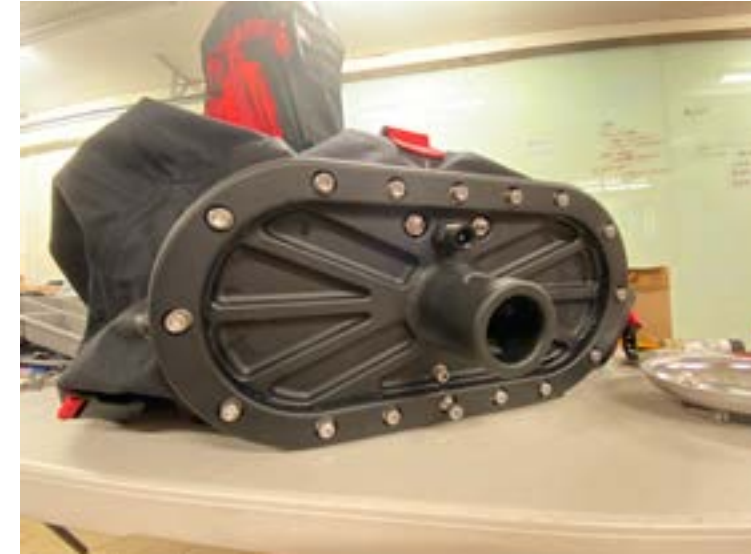
- 1.1 Set system on even ground (preferably padded) with the "Front" side toward you. Front face has the machined lift eye and manual actuation lanyard on it.

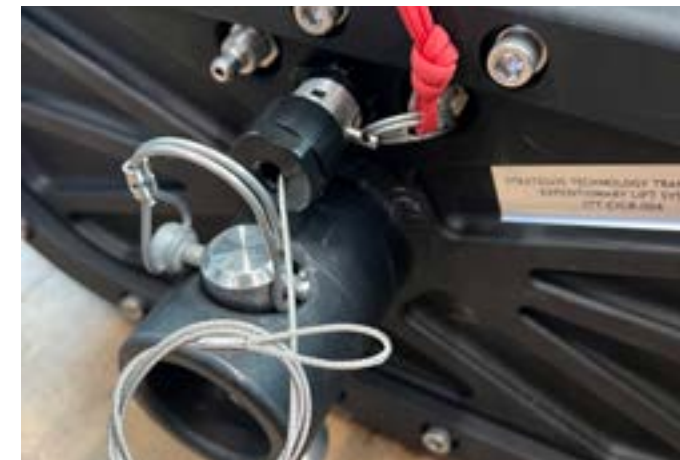
1.2 Safety Pin Inspection

1.2.1 Is the safety pin in?

- 1.2.1.1 No... The system has been fired and will need the lanyard and the actuator safety pin reset.

- 1.2.1.1.1 Follow Section 2 "Re-Fire Reset procedure on following page.

- 1.2.1.2 Yes... The system is ready to be rigged and is already prepared for service
